OVERVIEW

This 1928 landmark, listed as the Mutual Building on the National Register of Historic Places and renamed The Christman Building in 2008, was a brownfield site in Lansing, Michigan, near the state Capitol.

THE CHRISTMAN BUILDING: A CASE STUDY

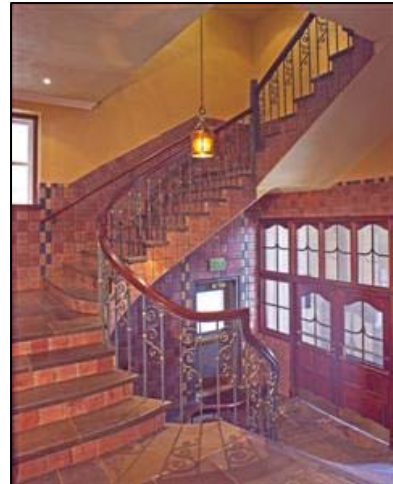
Restoration of historically significant building features included the main entrance doors and plaques, the mica shade light fixtures and Pewabic wall tiles in the main hall, and the light fixtures and verdigris bronze handrail finish in the stairwell and lower level.

All of the preservation work on the building was approved by the State Historic Preservation Office and the National Park Service to ensure that standards protecting the National Register building were upheld. Restoration of historically significant building features included the main entrance doors and plaques, the mica shade light fixtures and Pewabic wall tiles in the main hall, and the light fixtures and verdigris bronze handrail finish in the stairwell and lower level. Other restored and reused building components included door hardware, wood trim, wood windows, and floors in the entry and historic stair made of Bluestone or black and white linoleum. Bricks salvaged from the removal of the penthouse were used to patch exterior walls. Benign products, such as citrus strippers, wet grinding, and low VOC coatings, were used to restore historic finishes, such as the walnut paneling in the executive offices on the first floor. All plaster walls were restored, using several restoration techniques.

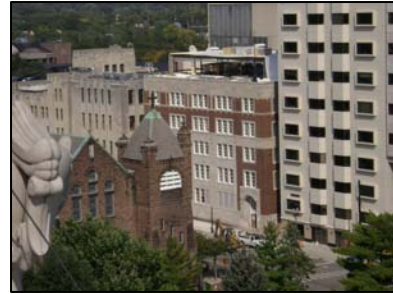
The original building housed an insurance company that insured many of Michigan’s mills. Numerous millstones from those mills had been incorporated in the sidewalk in front of the building. These were carefully extracted when the sidewalk was replaced and are now featured in the landscaping along the façade.

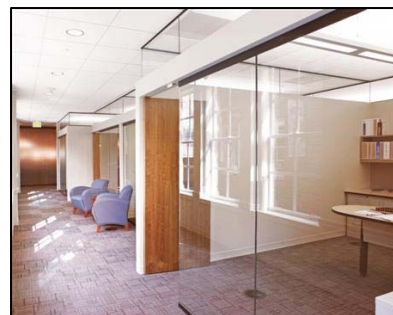
All workstations have individually controlled multi-level task lighting. The lighting energy savings are projected to be 27%. Use is controlled by occupancy sensors in private offices and stairways, programmed timers in common spaces, daylighting dimming controls, and individually controlled task lighting.

The design took advantage of large perimeter windows to provide daylighting to 92% of occupied spaces building-wide and outside views to 90% of the occupants in the Christman headquarters. Additional background lighting is provided by high efficiency fixtures and T-5 fluorescent lamps with a very high color rendering index (CRI). All workstations have individually controlled multi-level task lighting. The lighting system energy savings are projected to be 27%. Use is controlled by occupancy sensors in private offices and stairways, programmed timers in common spaces, daylighting dimming controls, and individually controlled task lighting.

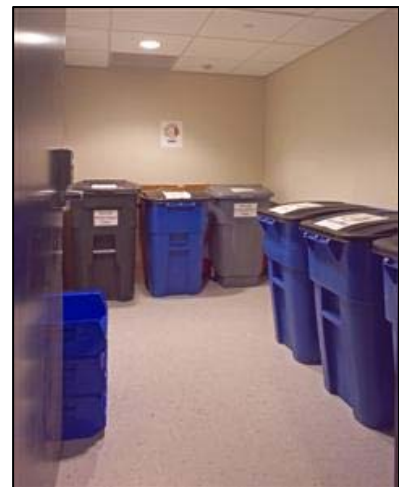
Recycling containers for paper at each desk and for other materials on each floor are emptied regularly and contents sent to a dedicated, central recycling room in the basement. Paper, plastic, cardboard, glass, batteries, lamps and metals are all recycled.

Recycling containers for paper at each desk and for other materials on each floor are emptied regularly and contents sent to a dedicated, central recycling room in the basement. Paper, plastic, cardboard, glass, batteries, lamps and metals are all recycled.

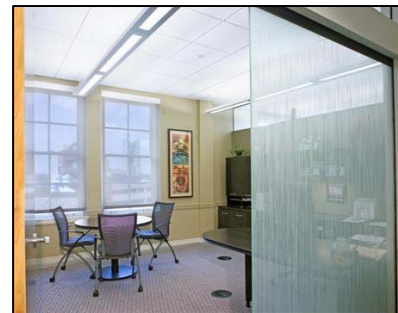
Large windows provide daylighting to 92% of occupied spaces building-wide and views to the outside for 90% of the occupants in The Christman Company commercial interior.

Large windows provide daylighting to 92% of occupied spaces building-wide and views to the outside for 90% of the occupants in The Christman Company commercial interior.
